# **Commercialization of Technologies to Lower Defense Costs**

## **Final Demonstration/Validation Report For STAPP Bullet Catcher Evaluation at Fort A.P. Hill**

**March 2, 2006**

Report Number: NDCEE-CR-2006-001

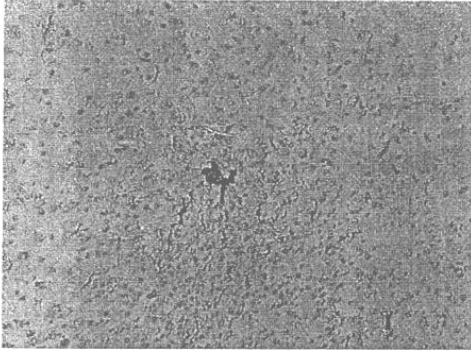
1. Example of wear damage which should be covered with a repair patch.
